Surveyor Spacecraft System

SURVEYOR IV FLIGHT PERFORMANCE
FINAL REPORT

JPL Contract 950056/September 1967

SSD 68189-4

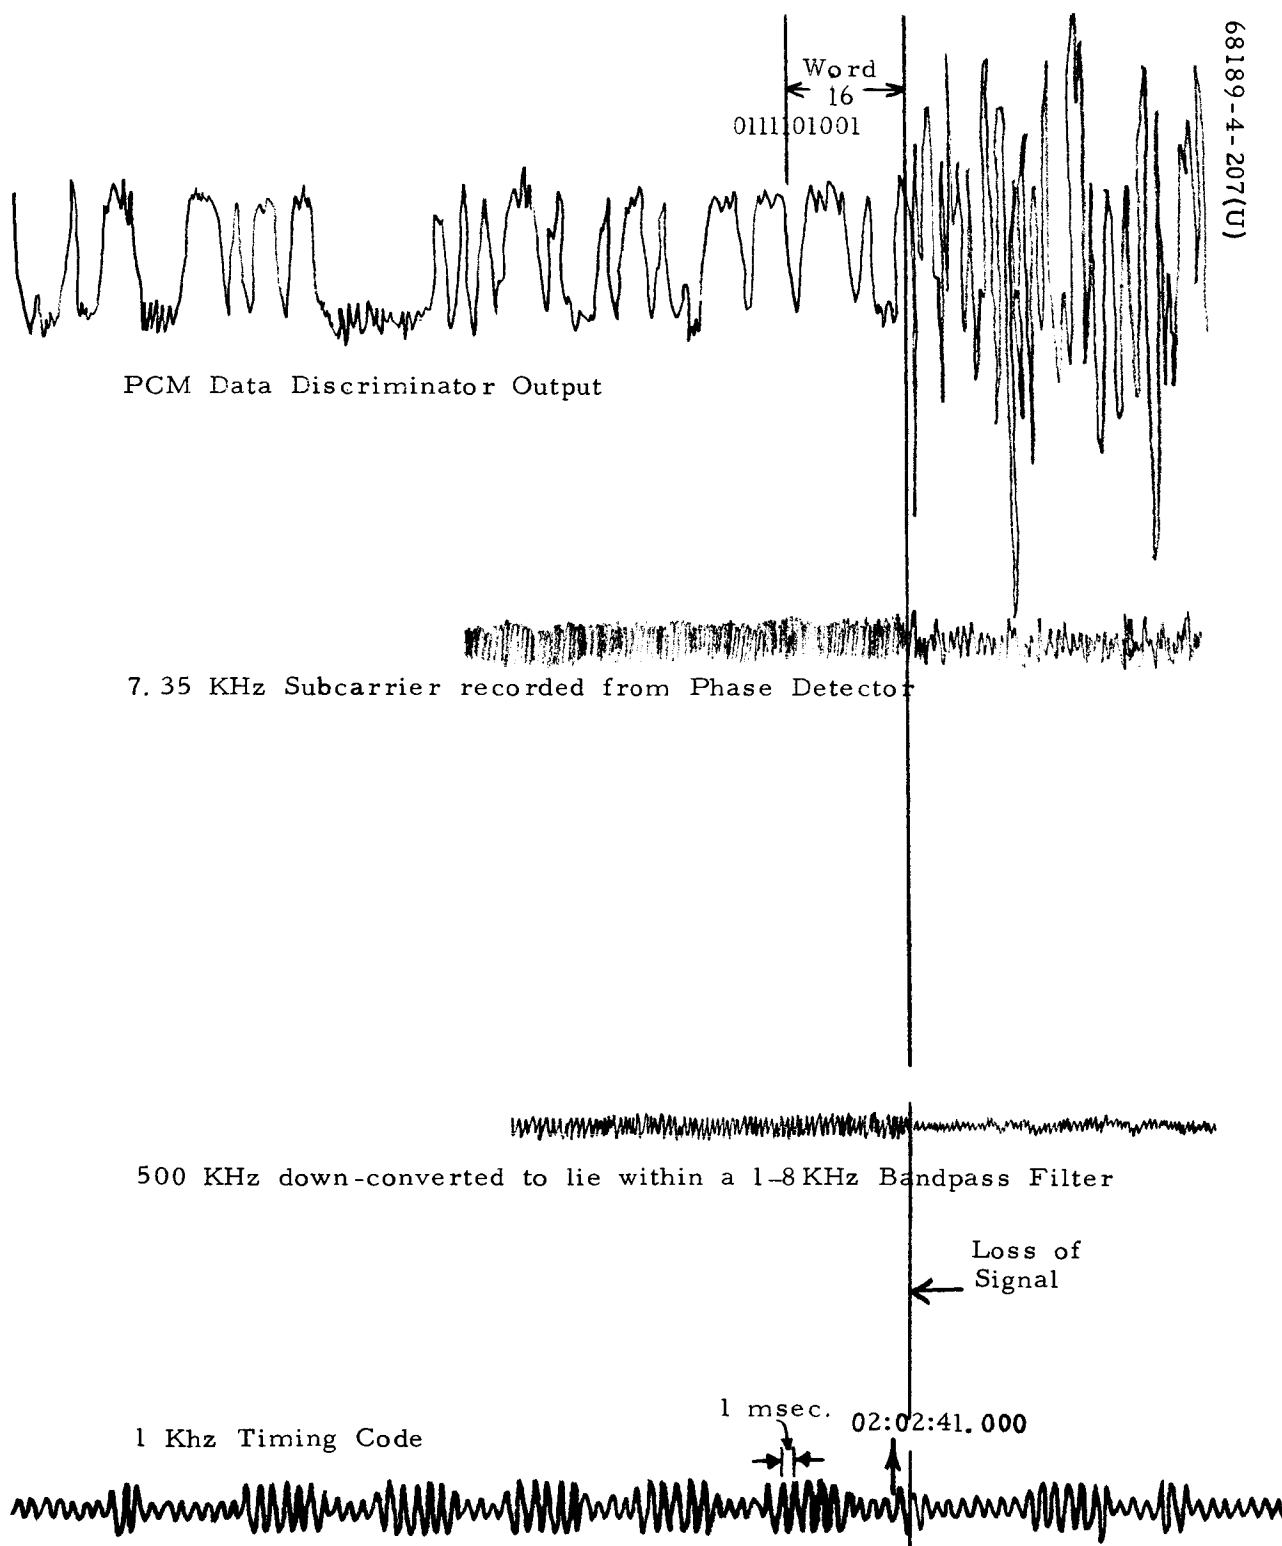
Figure 4-5. DSS-11 60 IPS Tape at Signal Loss

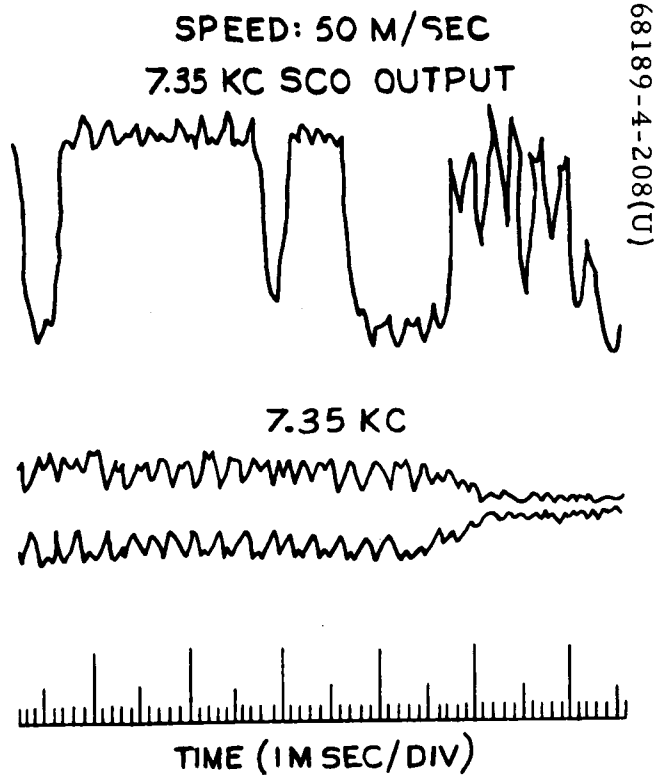
Figure 4-6a. SC-6 High Power Turn-off

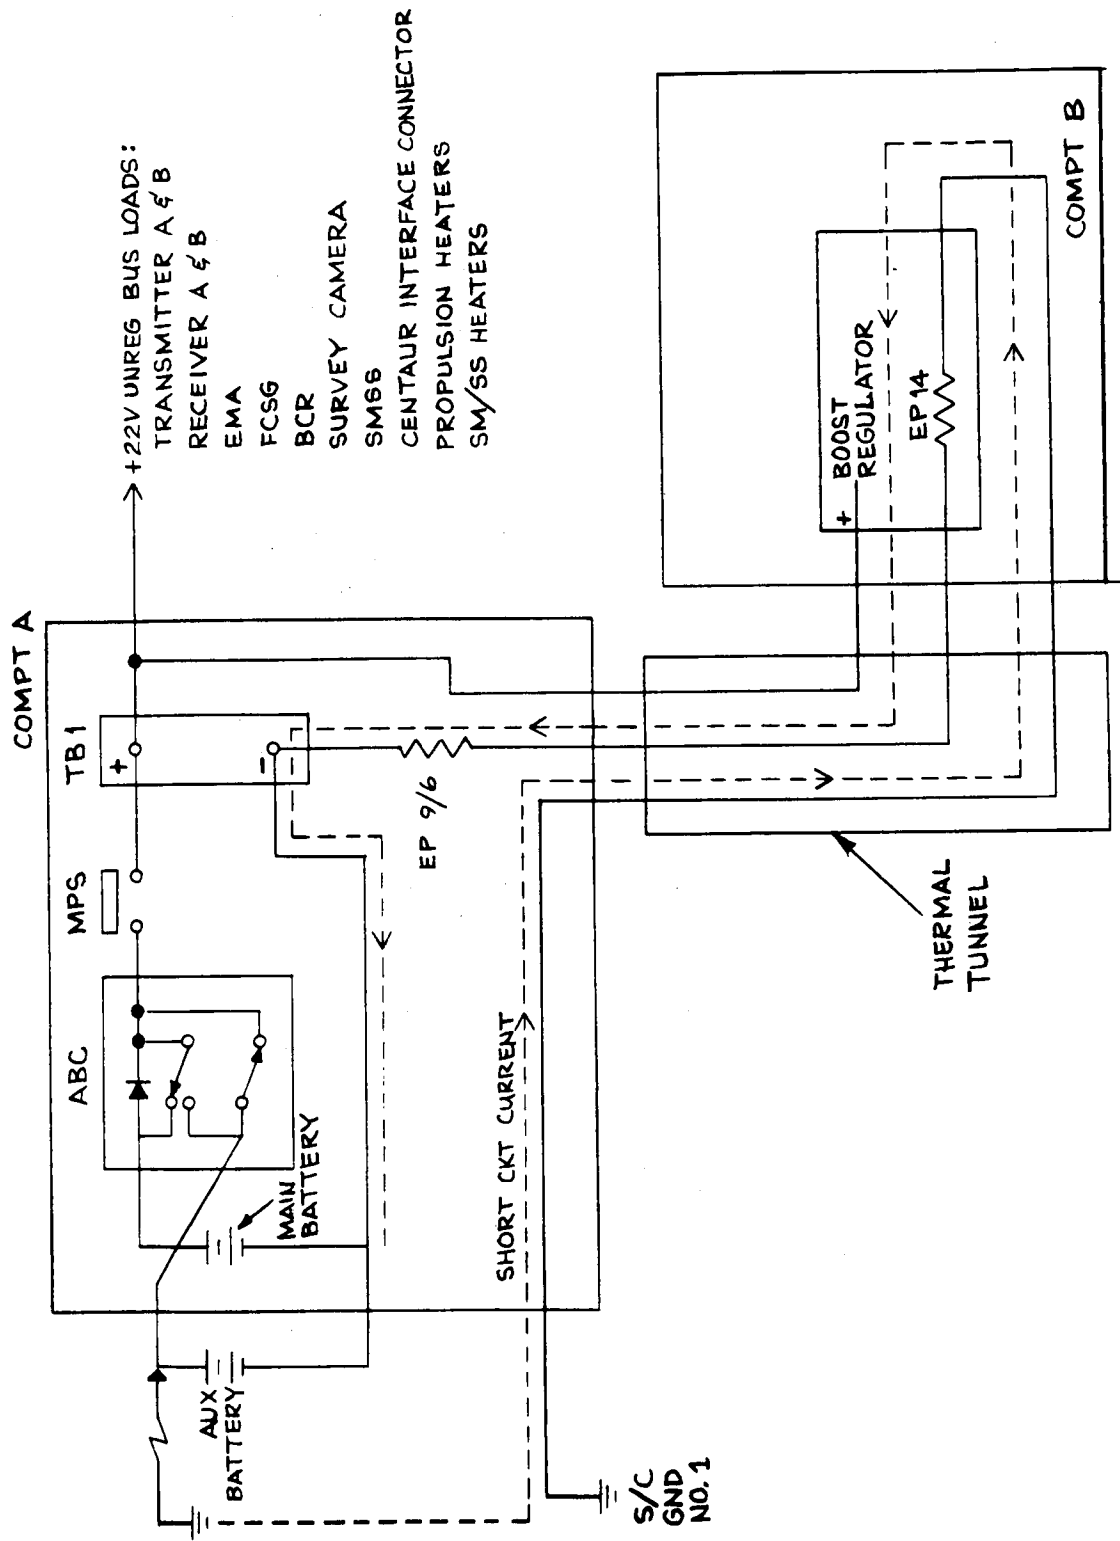
A short between almost all +22-volt unregulated bus points and the spaceframe can produce a short circuit in the range of 125 to 200 amperes. The exact value of this current will depend upon the location of the short.

Figure 4-7. Current Path, 29-Volt Unregulated Bus, Short to Ground

Figure 4-7 shows the path of the short circuit current through the spacecraft return leads. It also shows that the harness drop between the negative input terminals of the boost regulator and the negative terminals of the batteries will also lower the input voltage to the boost regulator. When this voltage drops below 17 volts, the overload trip circuit (OTC) will trip with loss of the nonessential bus resulting.

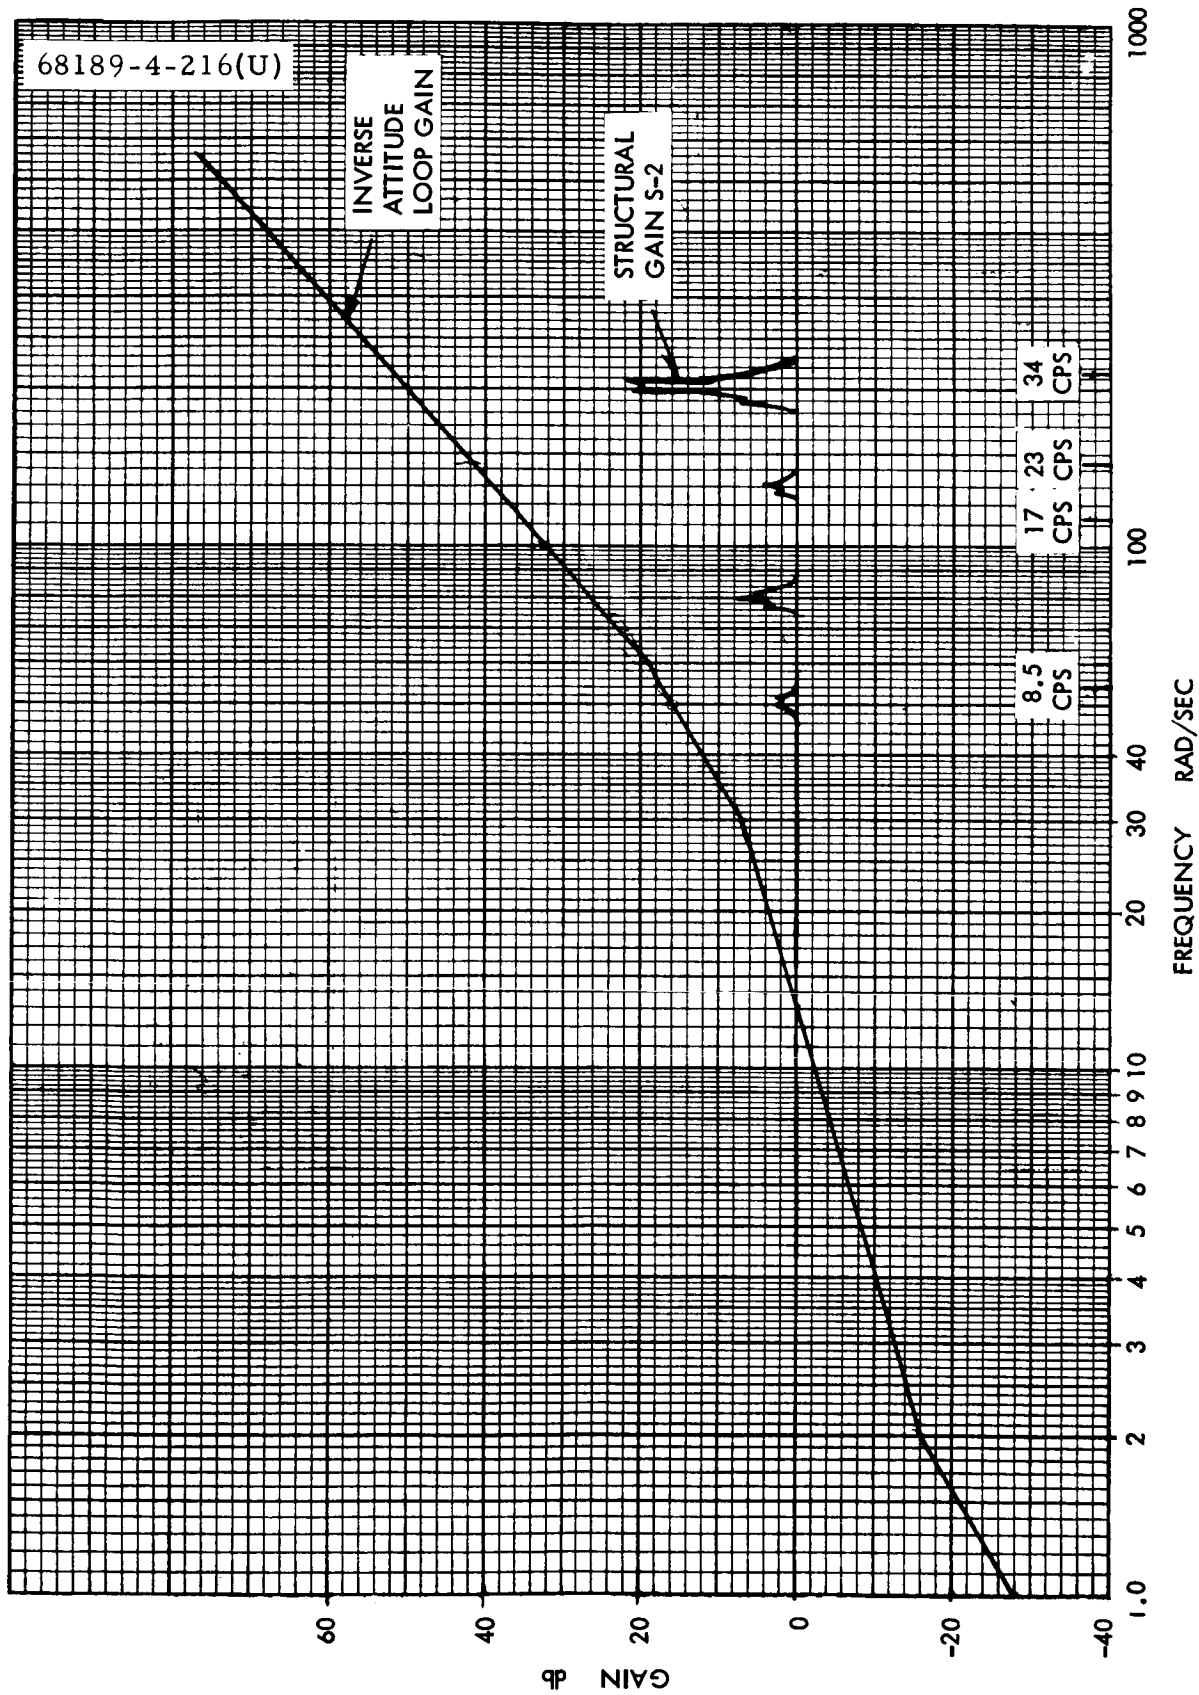
Figure 4-9. Structural Gain Necessary to Maintain Buzz in Attitude Loop

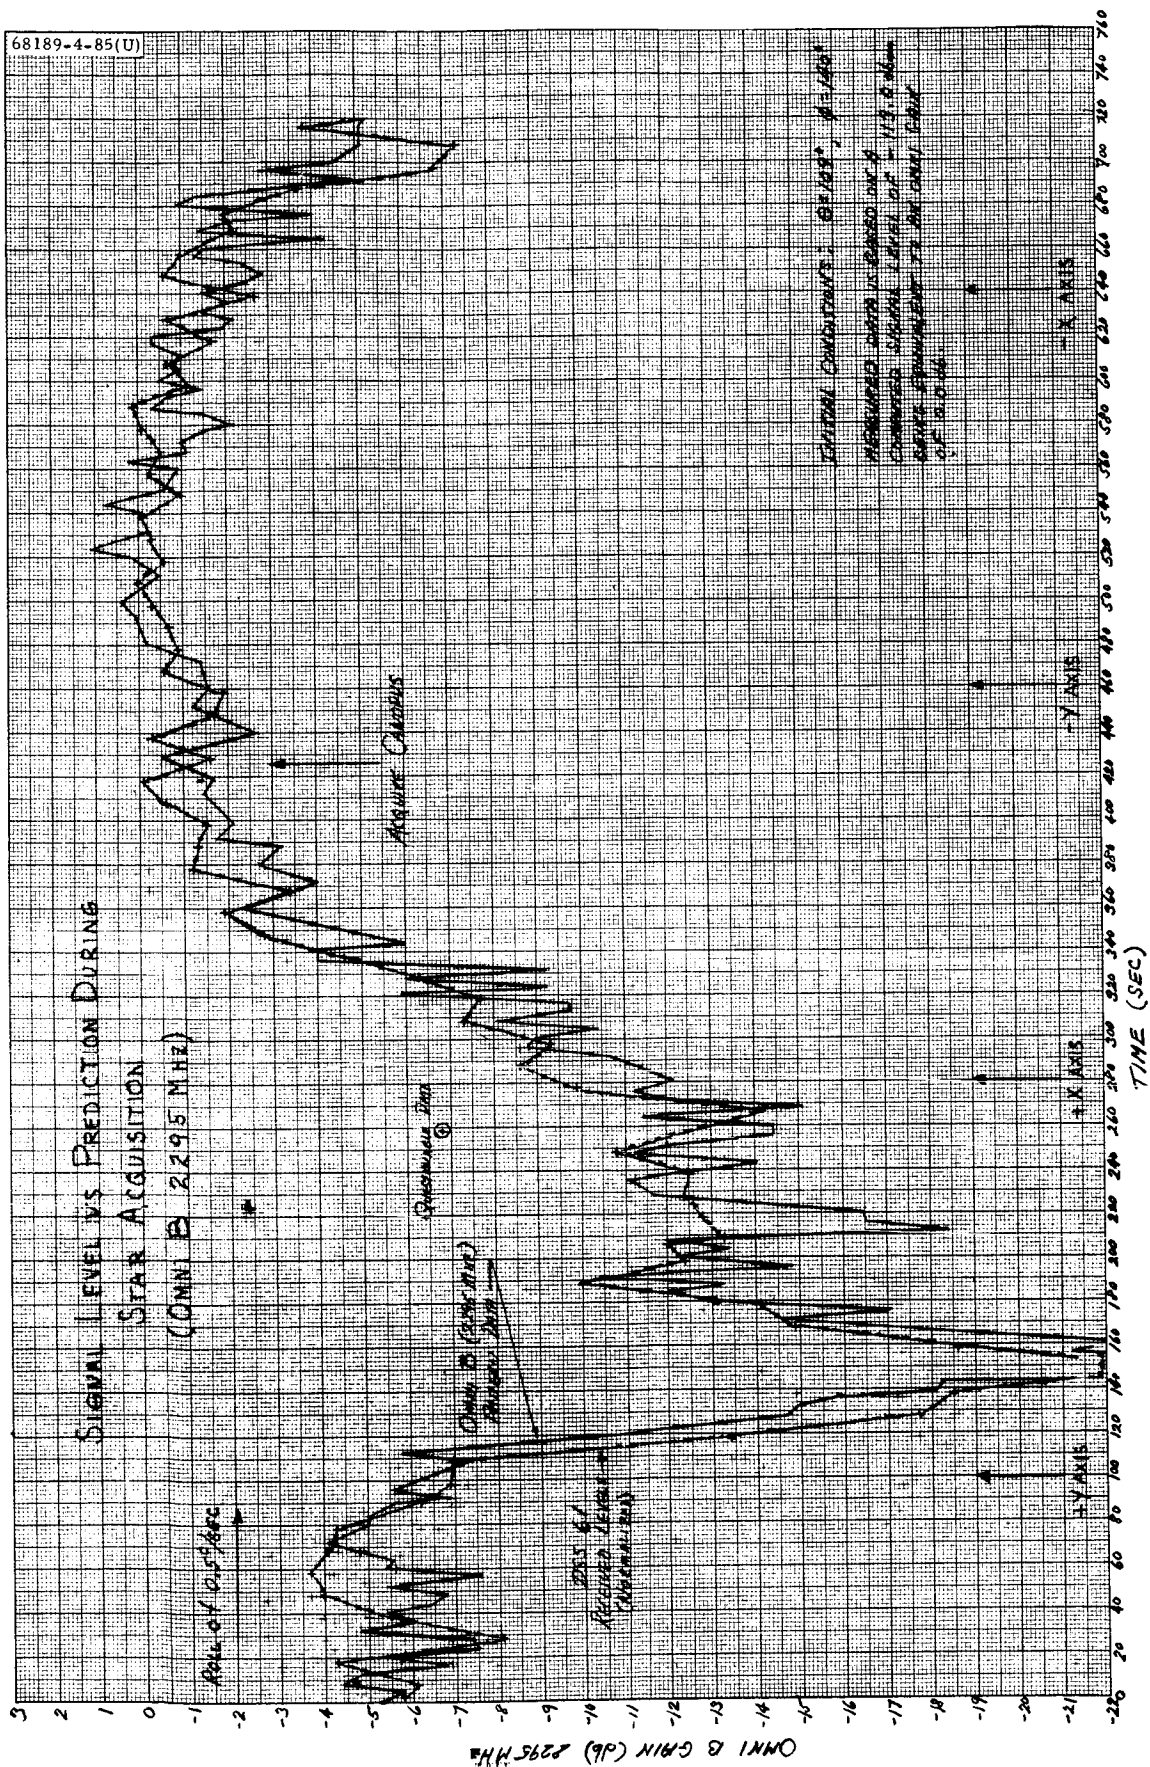
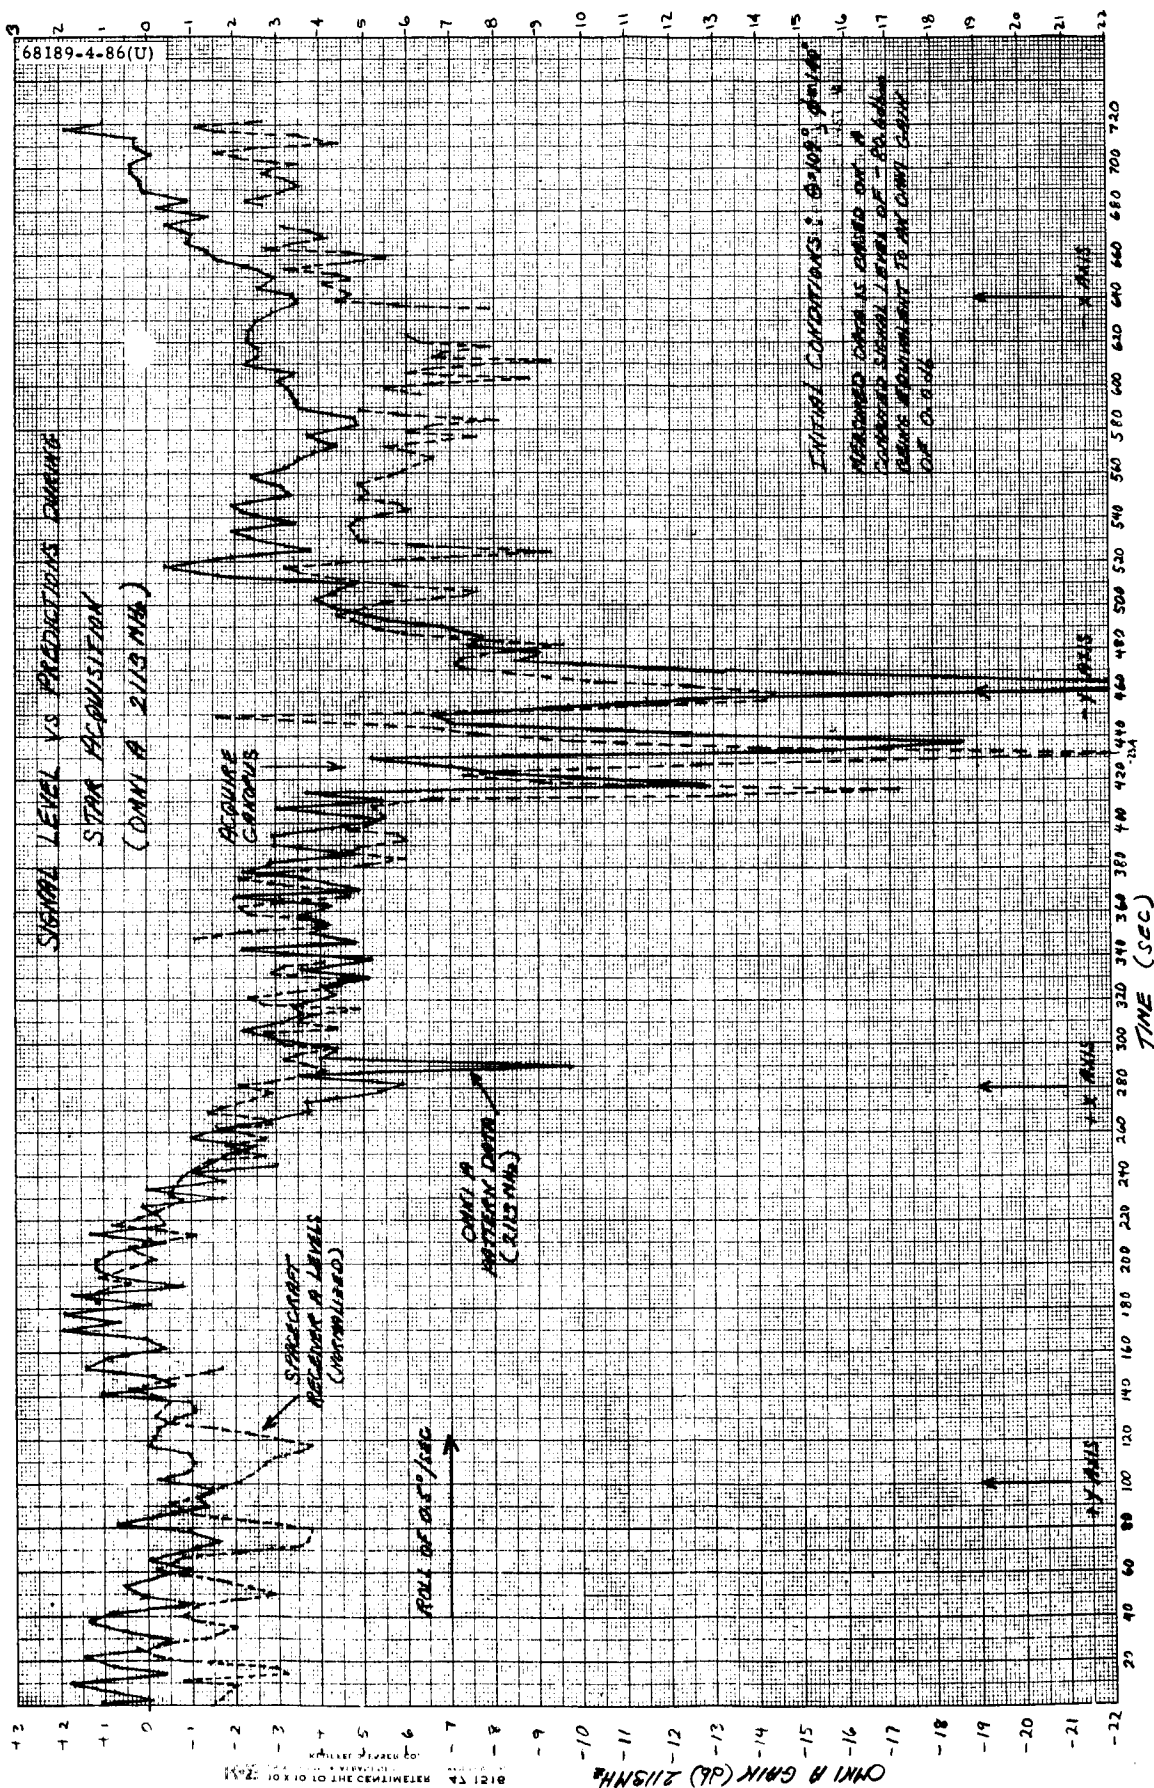
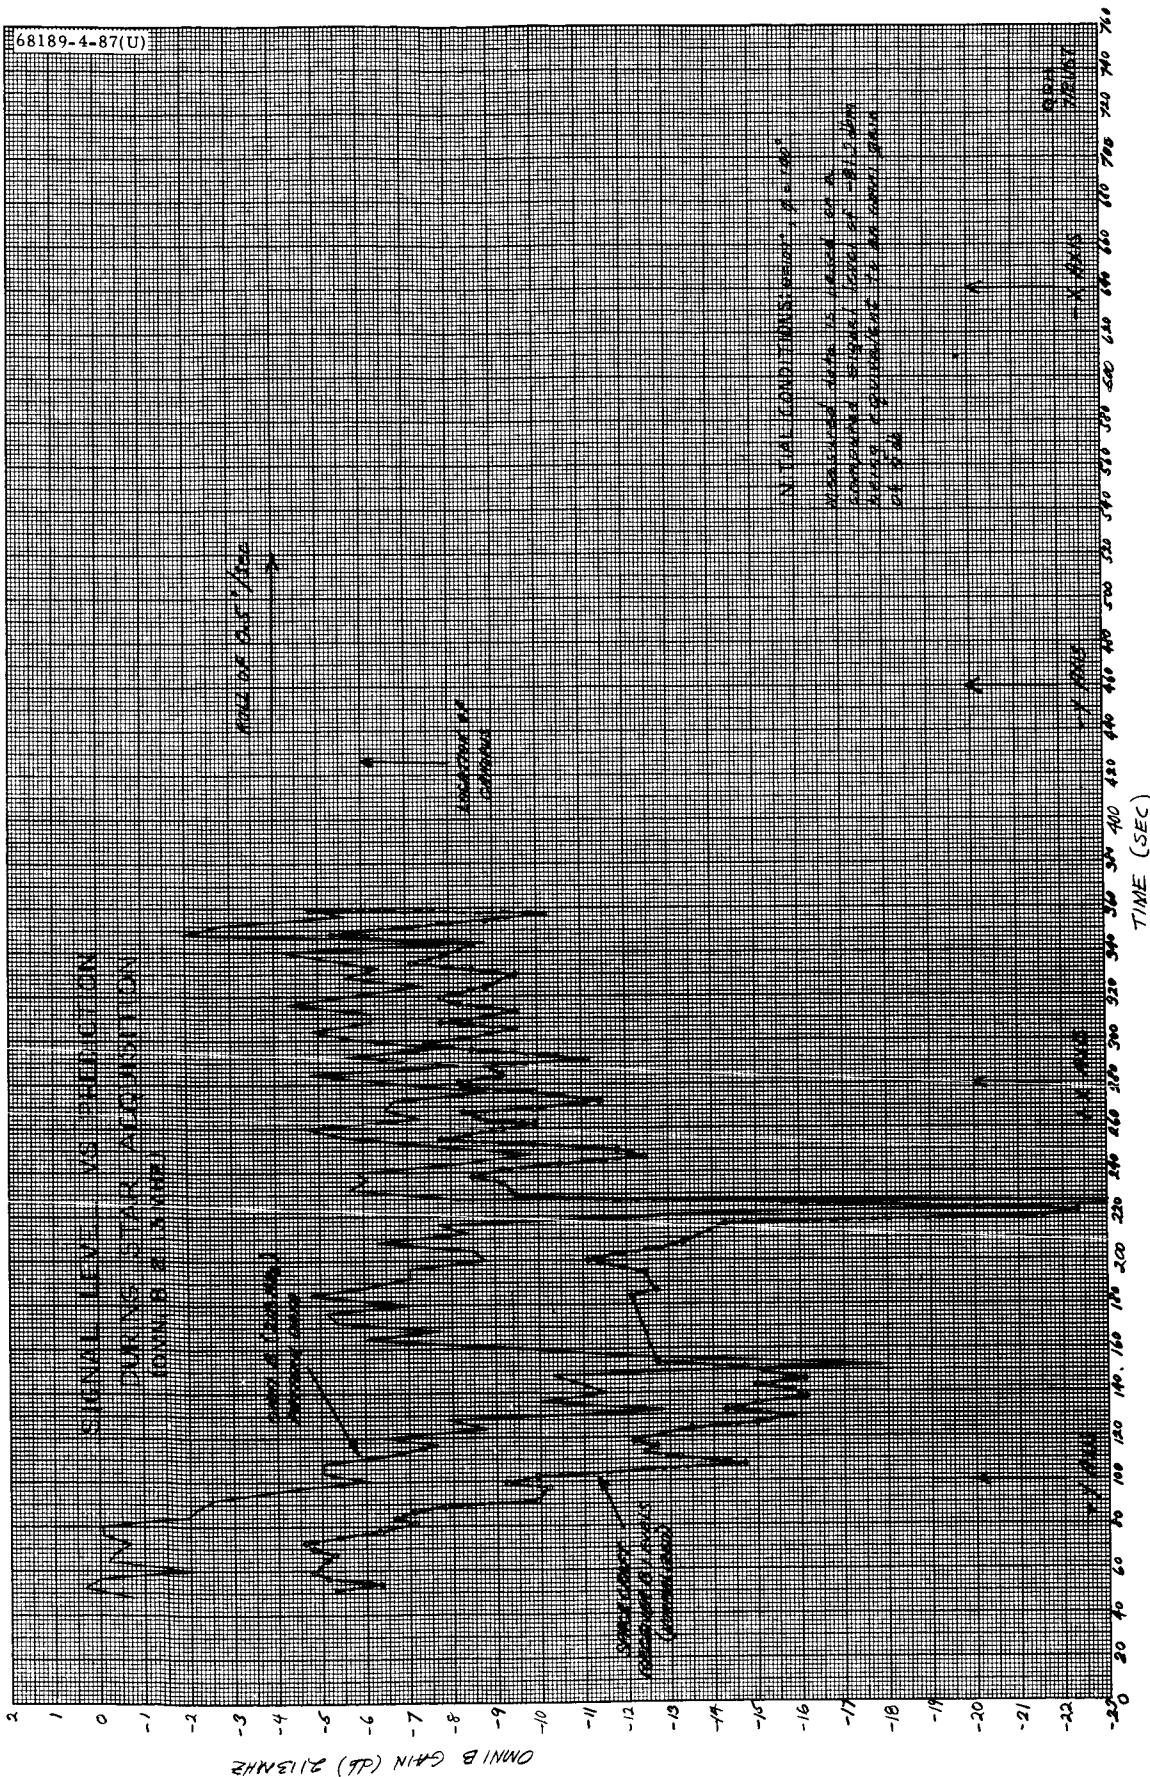
Figure 5.3-6 Signal Level Versus Predictions During Star Acquisition

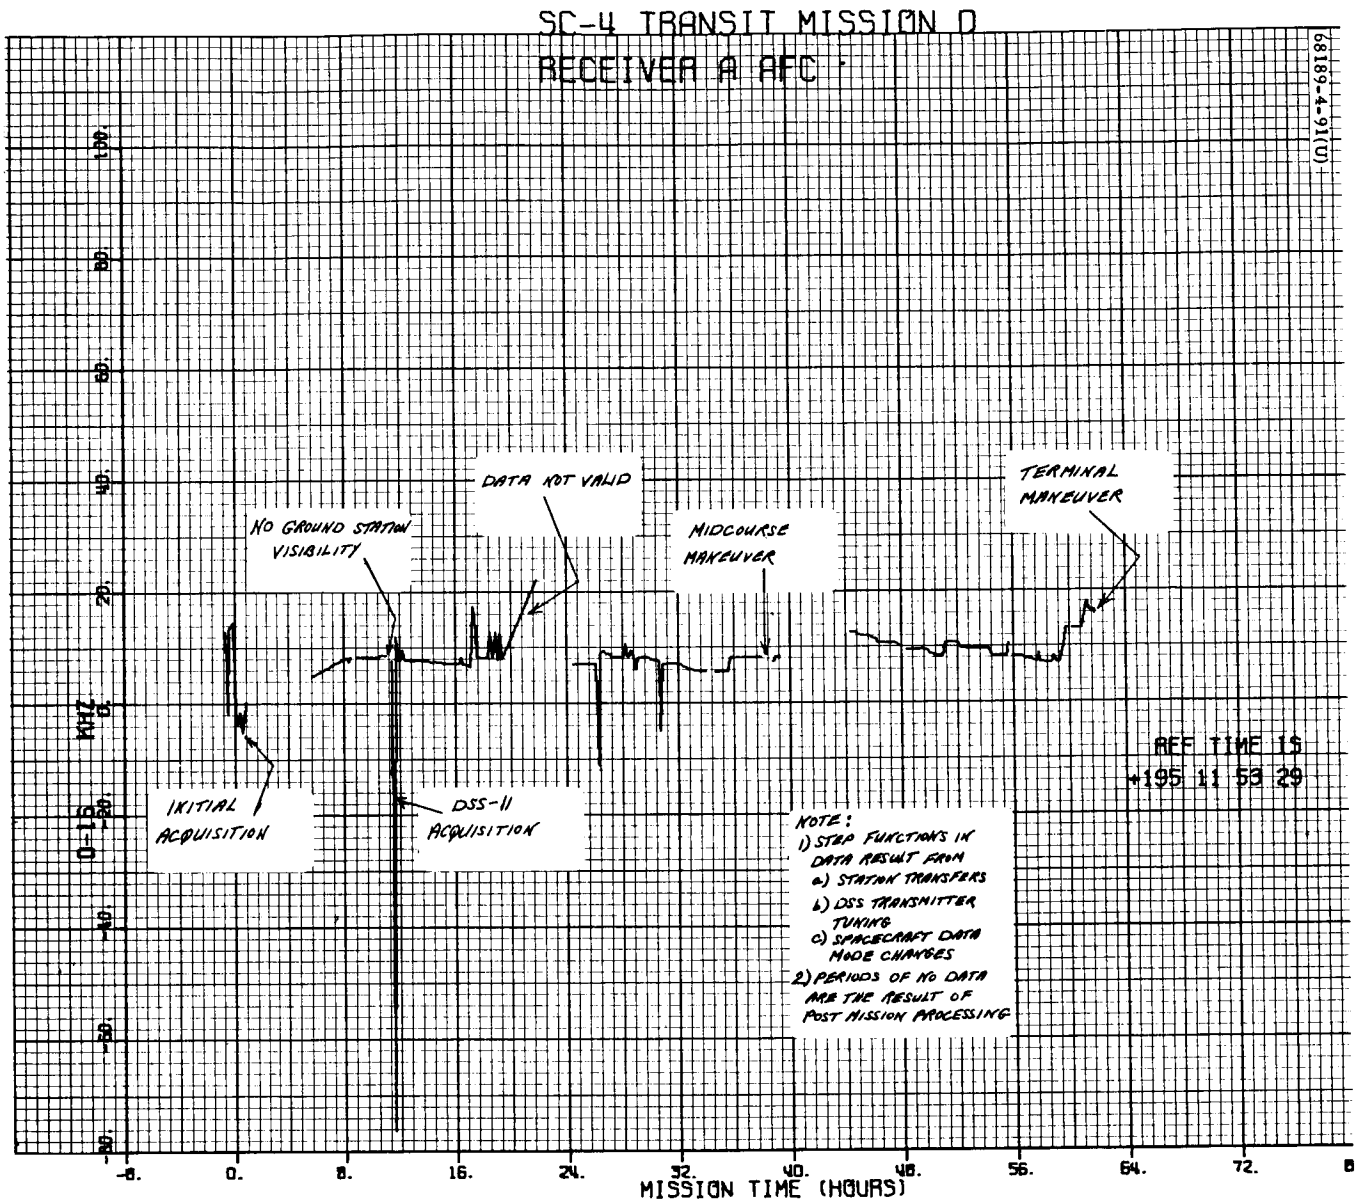
Figure 5.3-8. Received Automatic Frequency Control

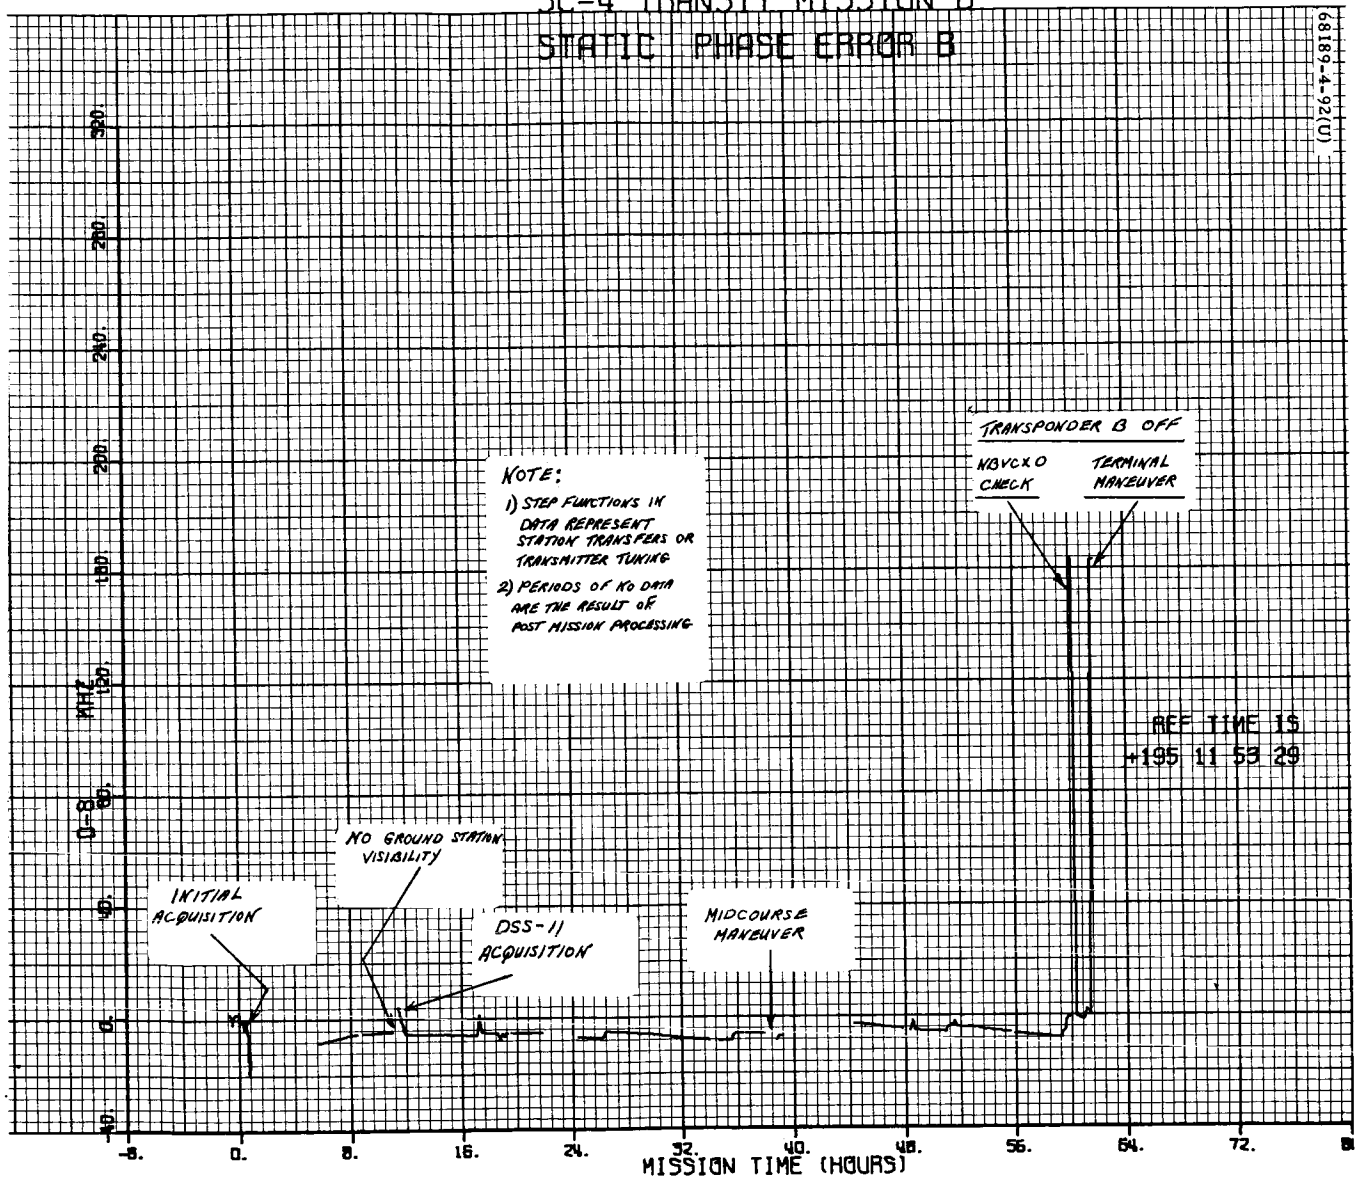
Figure 5.3-9. Receiver B Static Phase Error

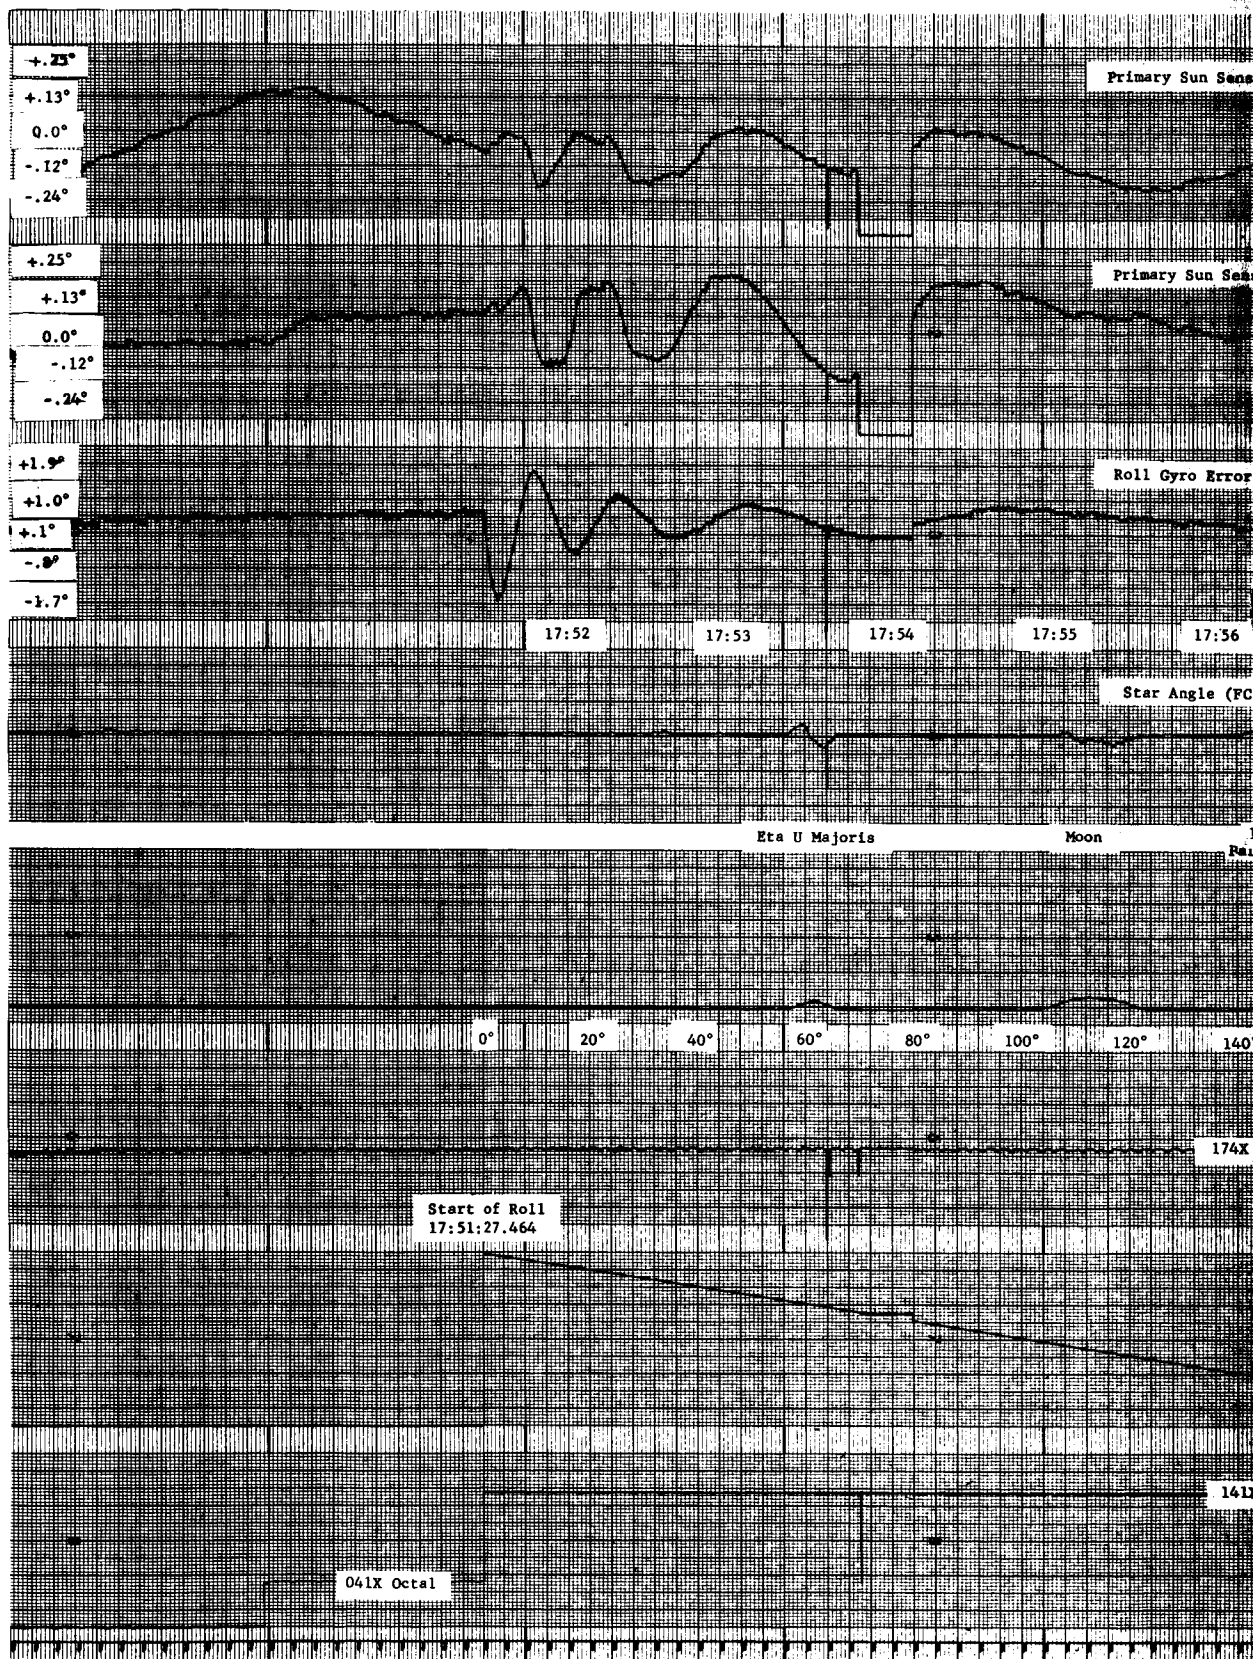
The mean roll rate, as determined from the incremental times Eta U Majoris and Delta Velorum are at the center of the field of view, is $720 / ((18:05:30.9 - 17:53:31.4) + (18:09:45.9 - 17:57:46.2)) = 720 / (11:59.5 + 11:59.7) = 720 / 1439.2 = 0.5003 \text{ deg/sec}$. This rate is 0.06 percent faster than 0.5 deg/sec. The error due to sampling time is $0.3 \text{ sec} / 720 \text{ sec} = 0.004 \text{ percent}$.

Figure 5.5-6. Surveyor IV Star Map

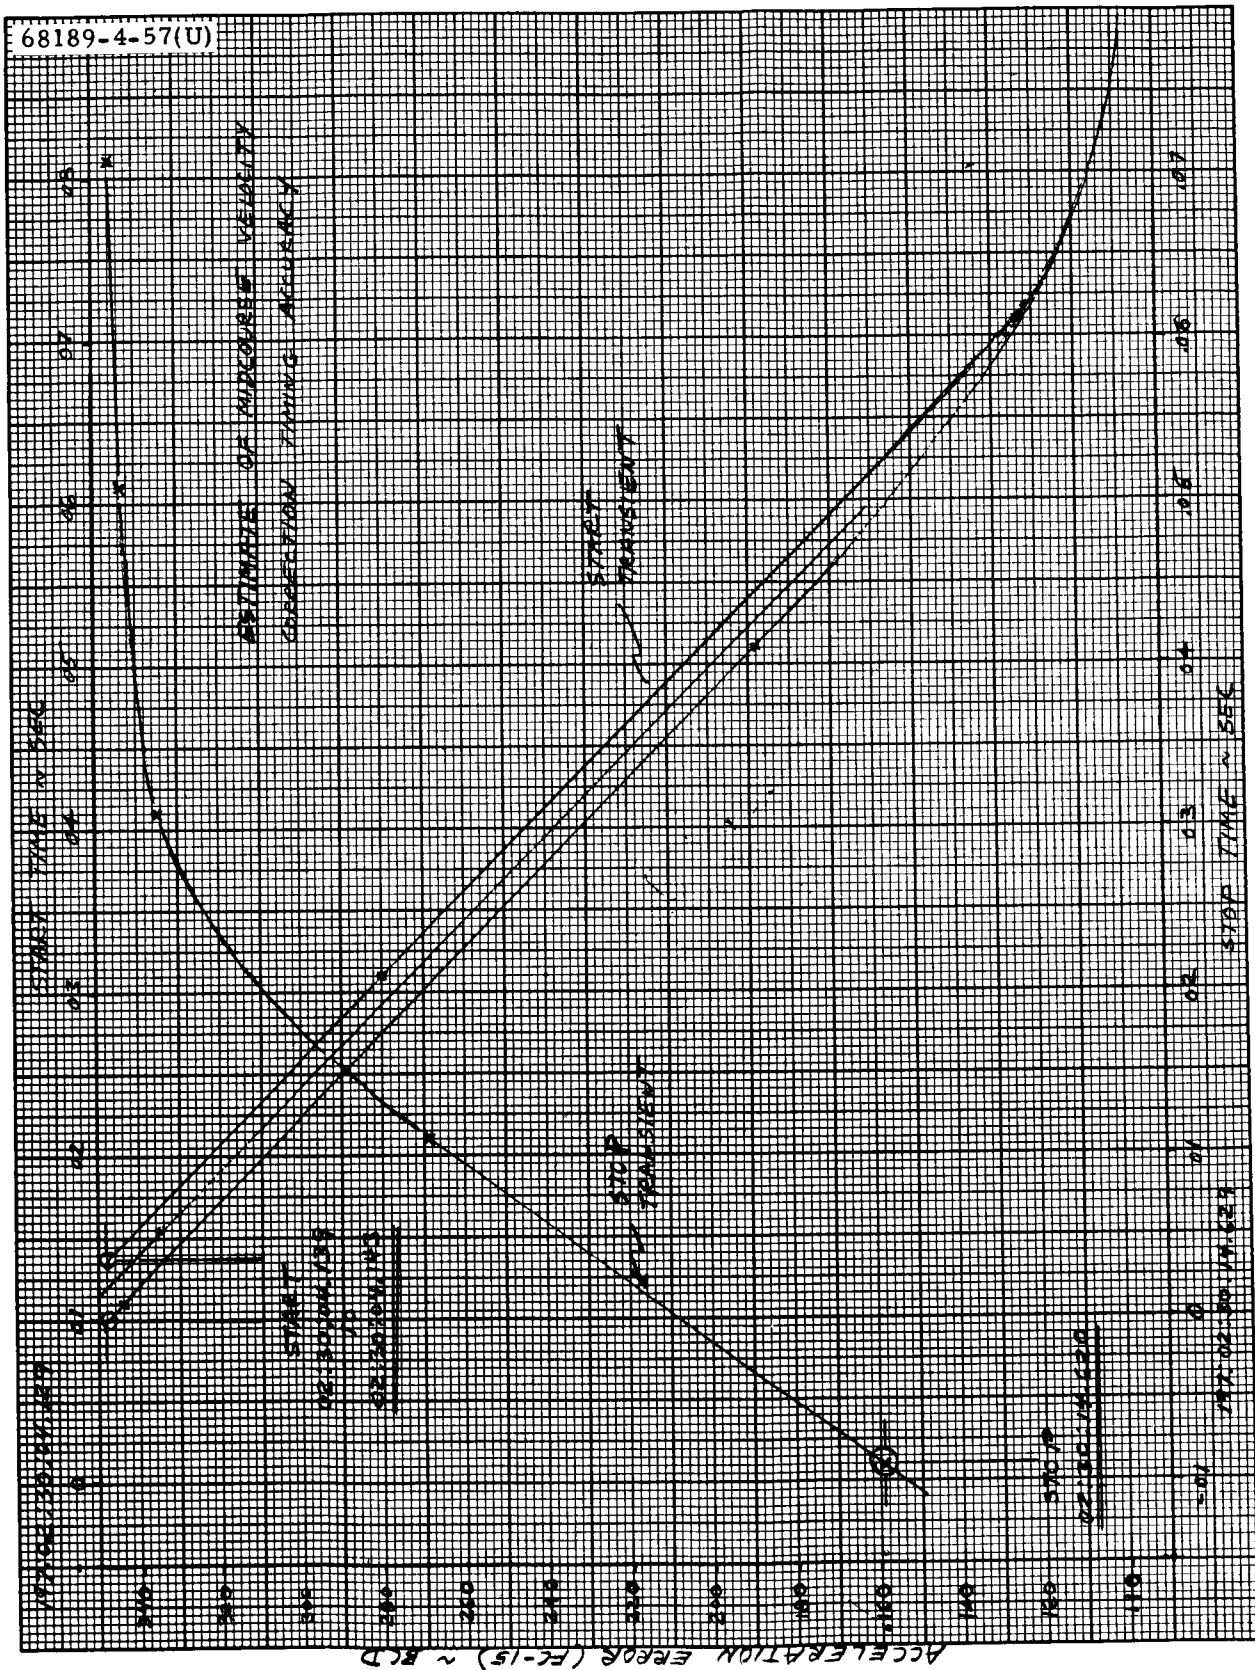
Duration of Burn Time. The acceleration error signal data were used in an attempt to determine the actual burn time. The results (Figure 5.5-16) indicated that the burn time was 10.479 seconds for a timing error of 0.02 second. (The magnitude register was loaded with 210 counts or ΔT = 10.5 seconds.)

Figure 5.5-16. Midcourse Velocity Correction
Timing accuracy using acceleration error (FC-15)

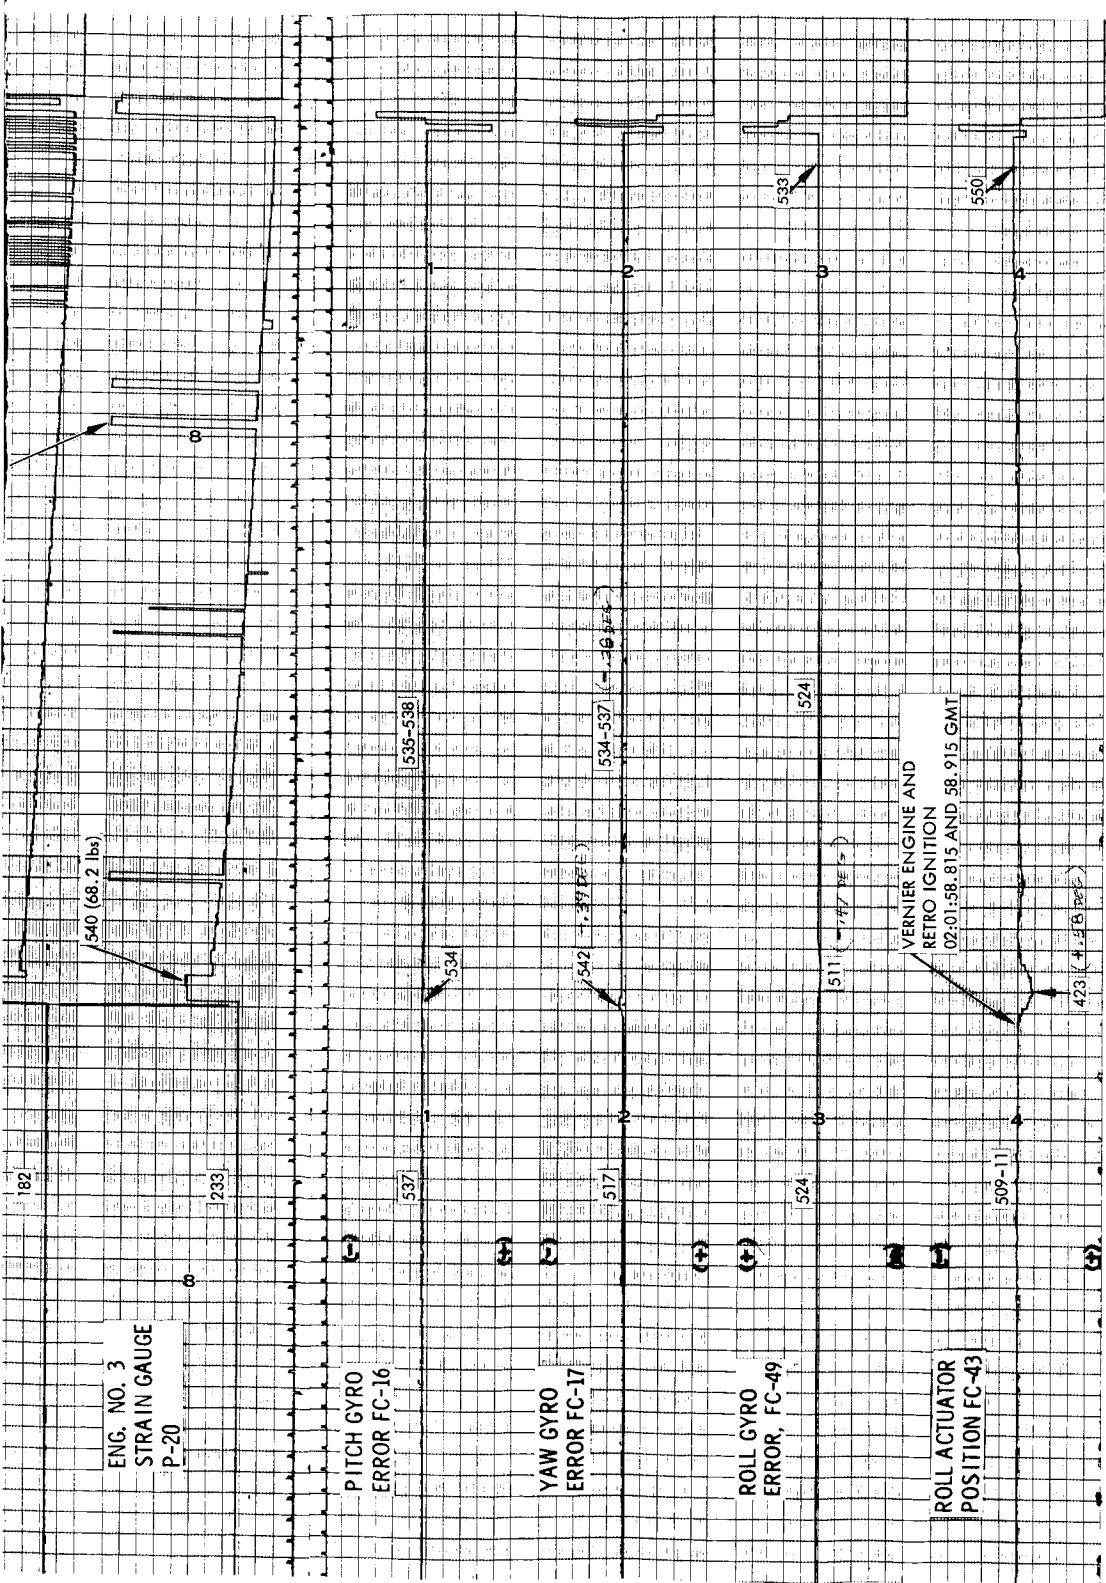
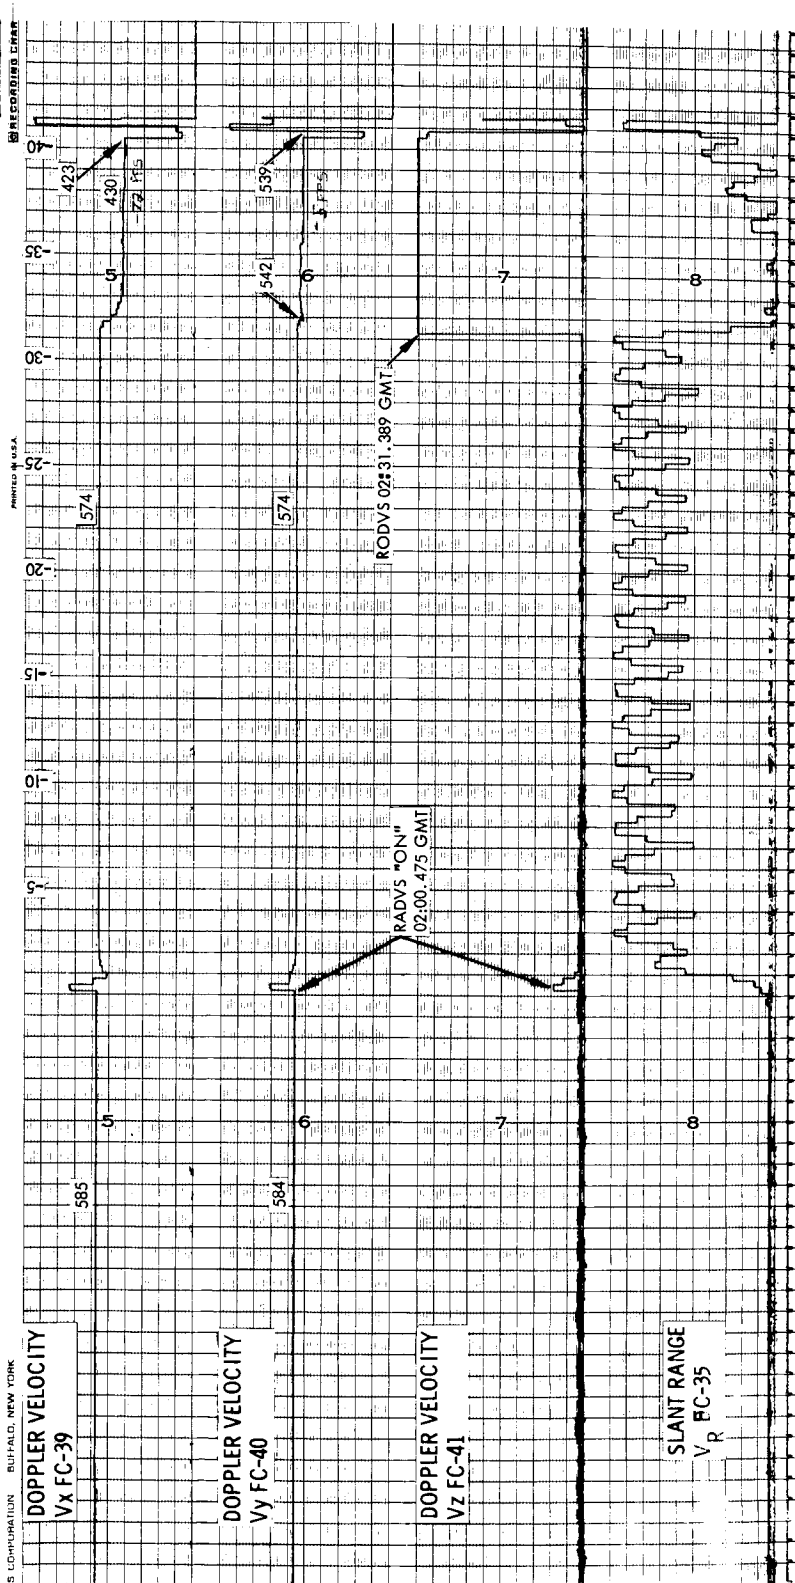
Figure 5.5-23. Surveyor IV Terminal Descent
